SITE VISIT RECORD

Site Visit Photographs

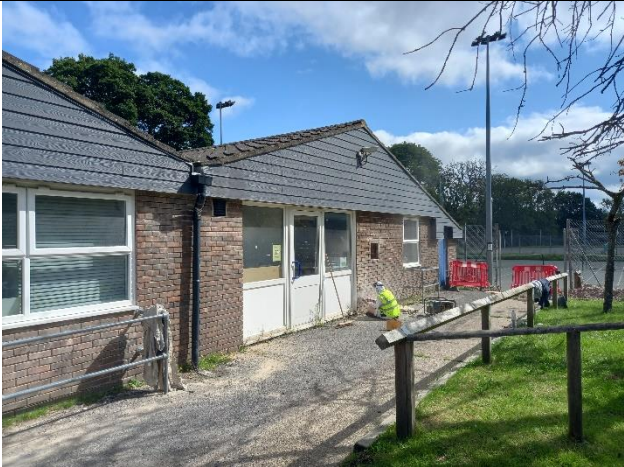
Photograph 1: Brickwork repairs on-going to Art Block.

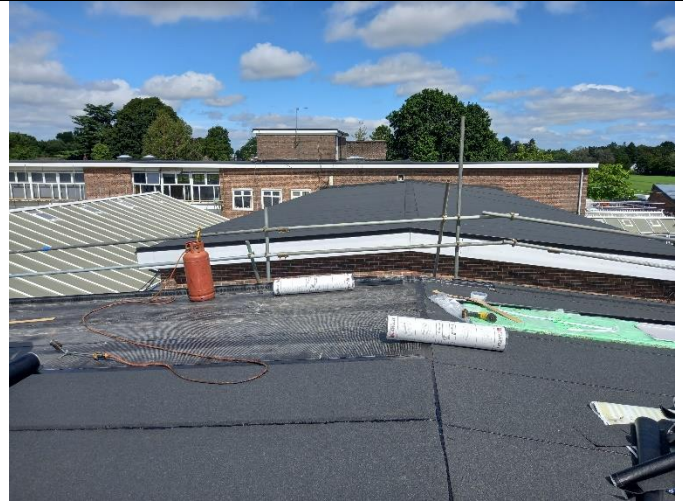
Photograph 2: Roof 7 - Works nearing completion.

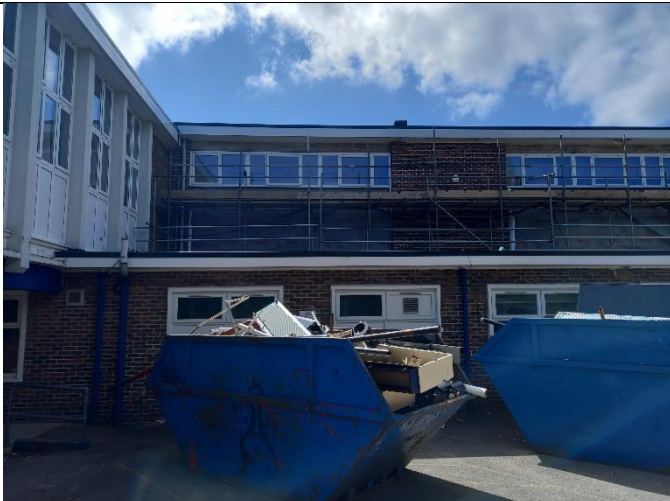
Photograph 3: English block, Asbestos containing cladding removal commenced.

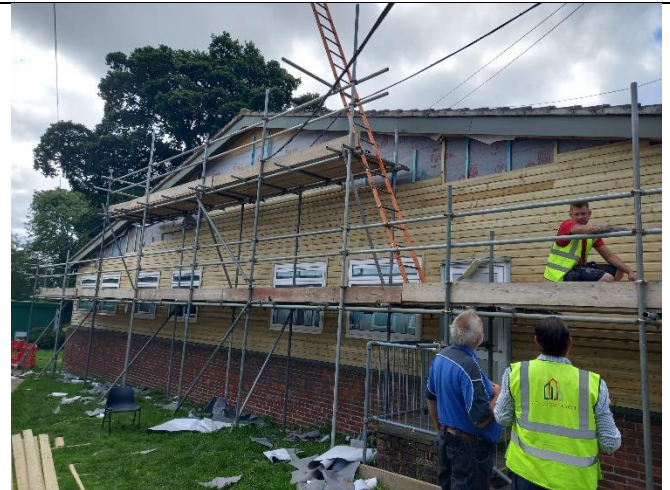
Photograph 4: Cladding installation complete to North Elevation.

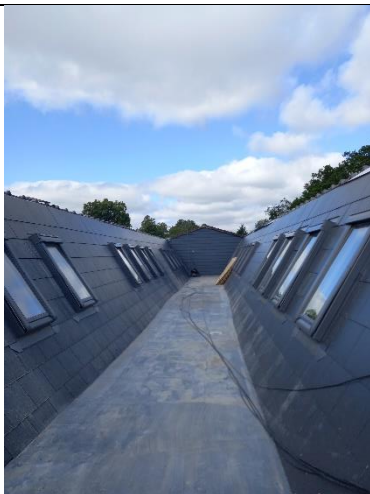
Photograph 5 - HSC Block - New Velux installations and artificial slates

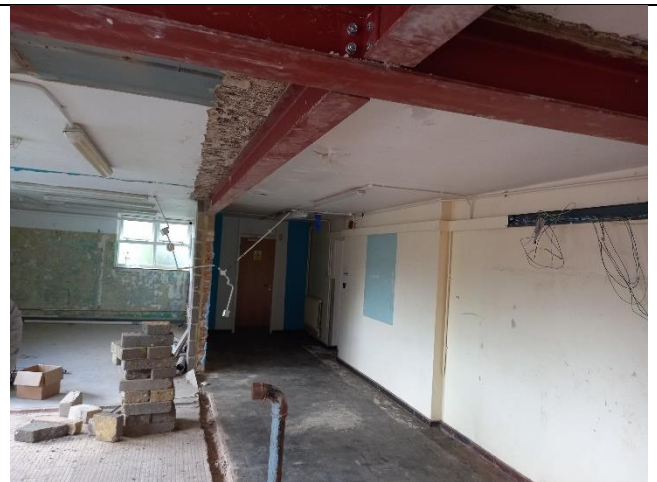
Photograph 6 - MFL toilets reconfiguration Steel installed.
